Blue River Fish Barrier Monitoring, 2014

Paul C. Marsh

Marsh & Associates, LLC
5016 S. Ash Avenue, Suite 108
Tempe, Arizona 85282

November 20, 2014

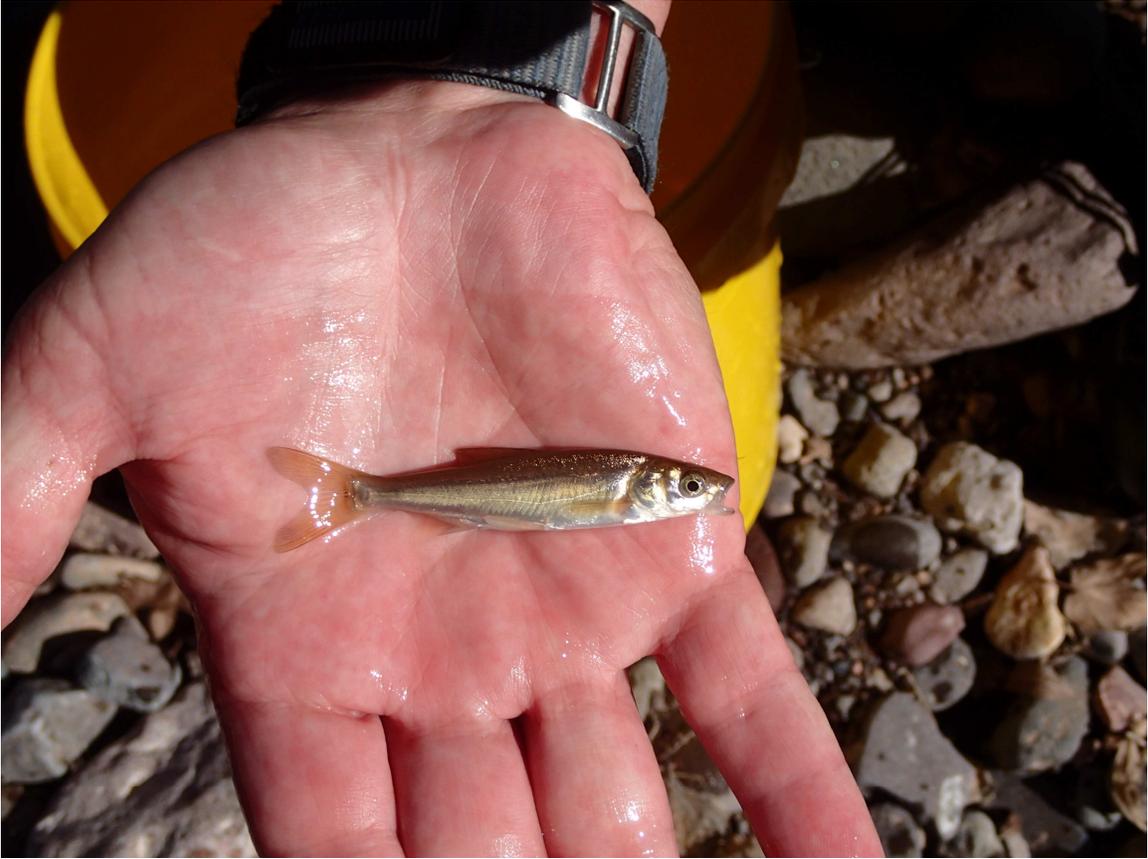
Figure 3. Roundtail chub *Gila robusta*; 70-mm TL, juvenile (age-0) captured in sub-reach 3, 400 m upstream of the constructed fish barrier, Blue River, Greenlee Co., Arizona. Photo by RWC taken October 29, 2014.

The 200-m sub-reach 3 (lower) random site was comprised of five mesohabitats: two riffles alternating with three runs. Riffles were deep and swift and had bottoms of cobble or cobble-sand; runs were sandy-gravel with a minor component of fines. Fishes were common and 130 individuals representing four species, native longfin dace, roundtail chub, Sonora sucker, and desert sucker (the last three all age-0) were captured in 861 sec electrofishing (Table 3). Measured roundtail chub were 70, 72, and 75 mm TL (Figure 3).

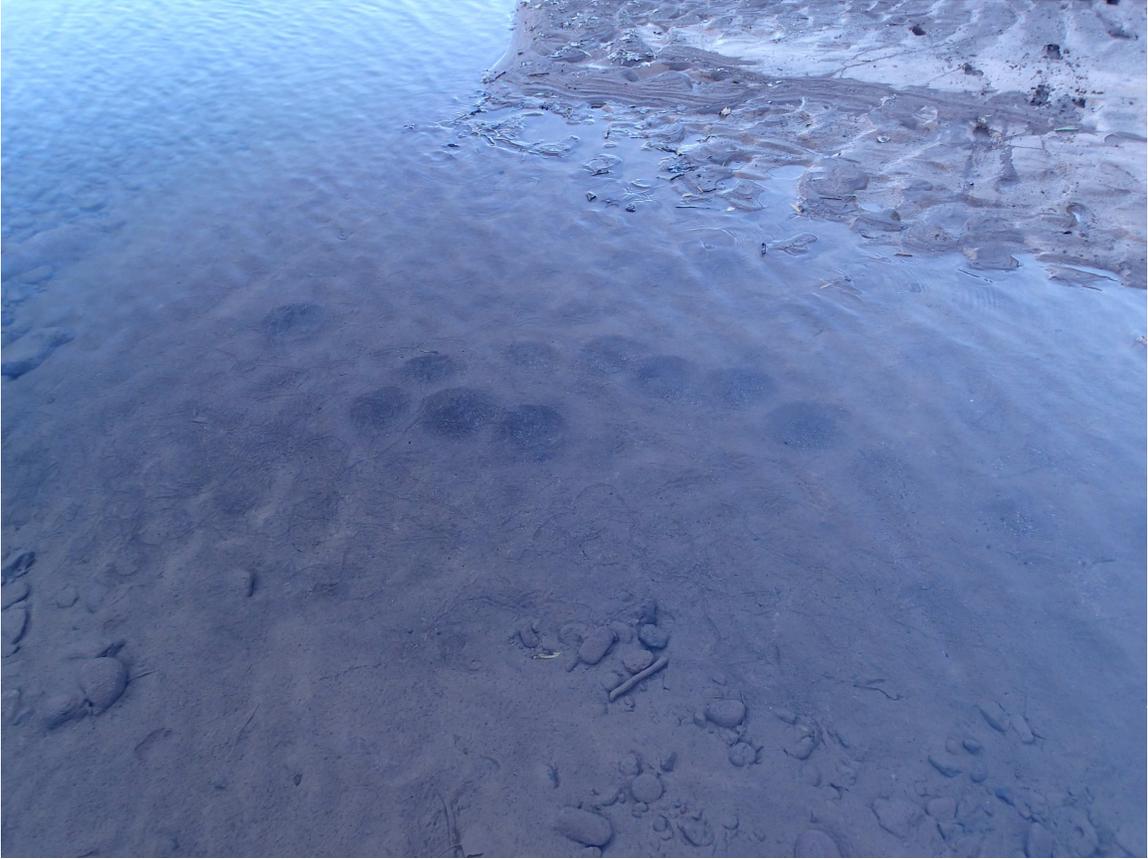
Figure 4. Blue River, Greenlee Co., Arizona, showing longfin dace *Agosia chrysogaster* spawning depressions or “nests” in soft, sandy substrate near the constructed fish barrier. Photo by RWC taken October 29, 2014.

Longfin dace nests were rare and restricted to a few depressions near the barrier (Figure 4); their presence suggests ongoing reproduction that is later into autumn than is typical for this species in cooler, higher elevation streams like Blue River (Minckley 1973, Kepner 1982).
